CONDITION ASSESSMENT OF TWO FIRE-DAMAGED HISTORICAL MARBLE SCULPTURES FROM BODE MUSEUM IN BERLIN BY NONDESTRUCTIVE ULTRASONIC TECHNIQUE

Abdelraheem Ahmad¹ and Stefan Simon²

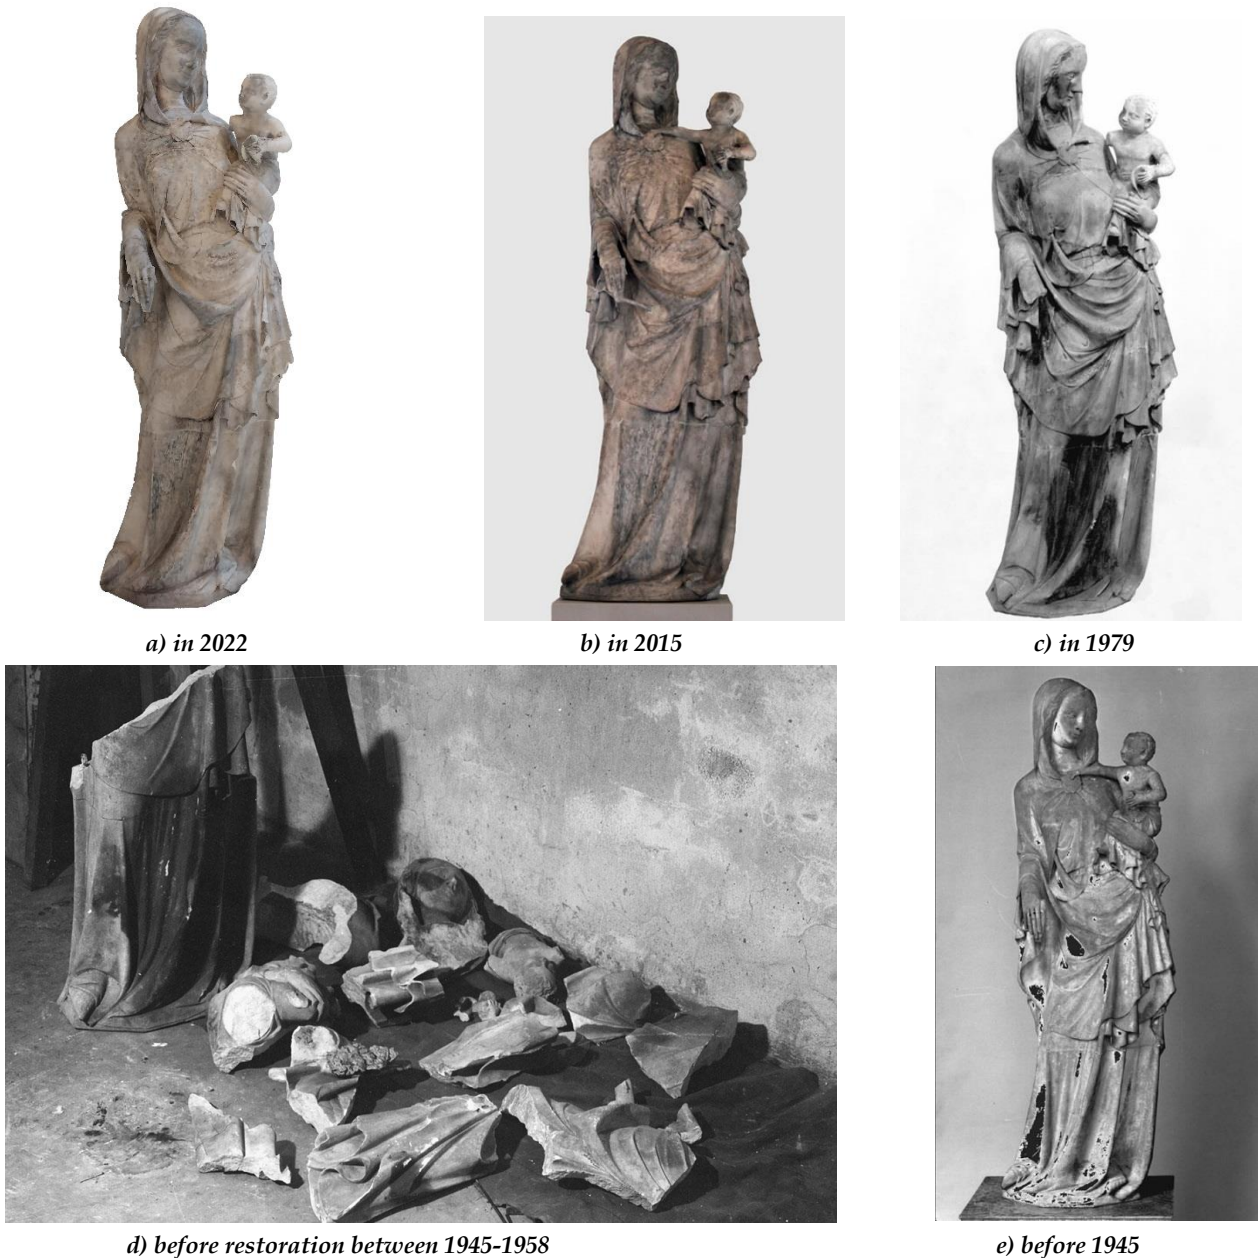
where it was damaged by fire. It was broken into many pieces (Fig. 1-d) and suffered various forms of damage including chipped edges, burnt and damaged surface with fine punctures, and several missing parts (Streich, 2015). However, the majority of the sculpture's original surface is still preserved.

Figure 1. Standing Mary with child (a) the condition in 2022 (by the first author); (b) in 2015 (from Streich (2015)); (c) in 1979 (from Streich (2015)); (d) before restoration between 1945-1958 (from Streich (2015)); (e) before 1945 (from Streich (2015)).

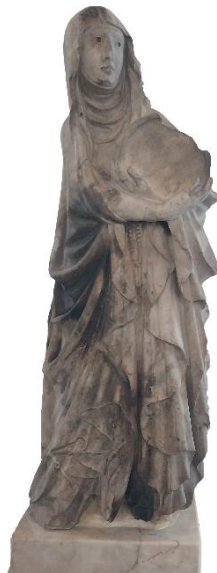
a) in 2022

The sculpture was stored in the Friedrichshain anti-aircraft bunker during the Second World War, where it was damaged by fire in May 1945. The intermediate storage place of the sculpture after the 1945 fire disaster is unknown. There is also no information about the restoration work that may have been carried out on the sculpture in the Soviet Union or later in East Germany (Streich, 2015).

Figure 2. *Humilitas (a) the condition in 2022 (by the first author); (b) in 2015 (from Streich (2015)); (c) in 1980s (from Streich (2015)); (d) before 1945 (from Streich (2015)).*

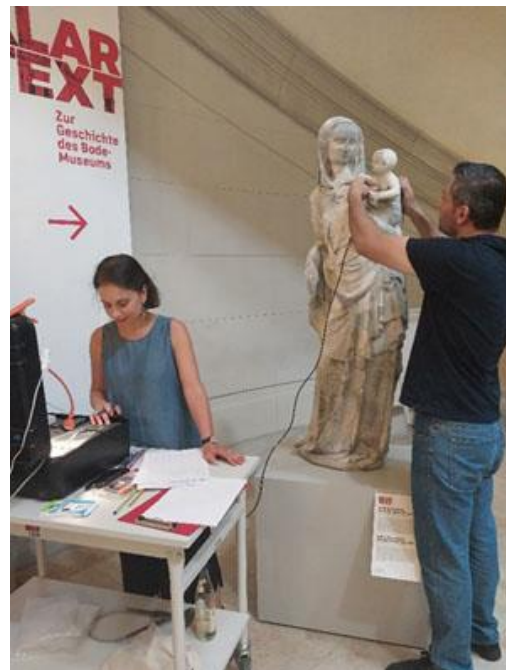
Figure 3. A photograph of performing ultrasonic velocity measurements on the sculpture of "Standing Mary with child" in Bode Museum.

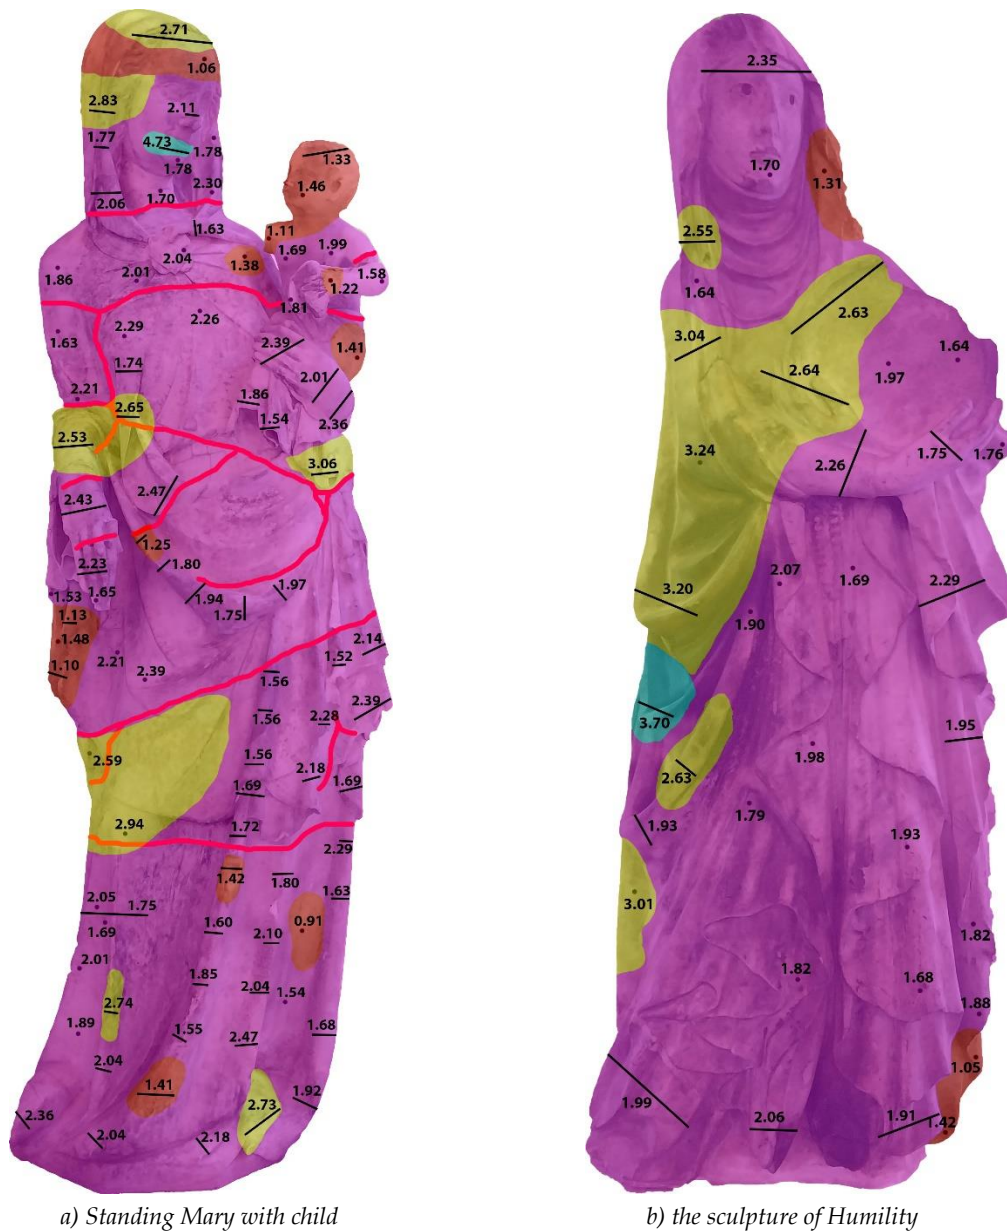
For the sculpture of Standing Mary with child, the average ultrasonic velocity of 92 measurement points is 1.94 km/s, which falls within the fourth class of damage, that is danger of breakdown, according to Table (2). This means that the sculpture has been damaged so badly that it may collapse or break into pieces when subjected to sufficiently high stresses.

In general, the sculpture contains areas with varying levels of damage. However, only one small area shows damage of the second class, corresponding to increasing porosity, while the rest parts of the sculpture exhibit more serious damage from granular disintegration to complete structural damage. This variation can be attributed to several factors, such as the varying degree of exposure to fire of its different parts, the dimensions of these parts, and the restoration work carried out on the sculpture. In fact, most parts of the sculpture suffer from very advanced damage of the fourth and fifth categories, which represent the danger of breakdown and complete structural damage respectively. Some parts of the sculpture may thus not be able to support their own weight.

The condition of the sculpture of Humility is not much different from that of Standing Mary. The sculpture has a slightly higher average ultrasonic velocity of 2.12 km/s, which corresponds to the fourth class of damage represented by danger of breakdown. The sculpture shows areas with advanced damage ranging essentially between granular disintegration and complete structural damage, except for one area

exhibiting a lower level of damage that corresponds to increasing porosity.

Figure 4. Mapping the damage classes of the sculptures based on ultrasonic velocity measurements and the adopted classification system (Table 2). The red lines indicate visible breaks and cracks, while the black lines and dots indicate the directions of ultrasonic measurement; the dots refer to front-back vertical directions.

Considering this advanced and severe damage exhibited by the two examined sculptures, interventive structural conservation treatments seems to be indispensable, especially for the parts with damage of the fourth and fifth classes, corresponding to danger of break down and complete structural damage. The proposed interventions include the consolidation of weak and fragile parts of the sculptures (areas with damage class 3 and higher) and the stabilization and support of their heavily loaded parts. At least, all parts with ultrasonic velocity below 3 km/s need to be conserved by consolidation or other suitable conservation measures (Menningen et al., 2020). Marble with ultrasonic velocity below the threshold value of 3 km/s exhibit usually damage ranging from extensive granular disintegration to complete structural damage. It is worth mentioning here that the consolidation material and its application method should be carefully selected in order to avoid adverse effects (Menningen et al., 2020). Ultrasonic technique can be used to evaluate the effectiveness of the applied consolidation treatments by comparing the results of ultrasonic velocity measurements before and after treatment.
