# DETERIORATION FACTORS FACING MURAL PAINTINGS IN EL SAKAKENY PALACE (PROBLEMS AND SOLUTIONS)

Kholod K.Salama<sup>1</sup>, Mona F.Ali<sup>2</sup>, Abubakr M. Moussa<sup>2</sup>

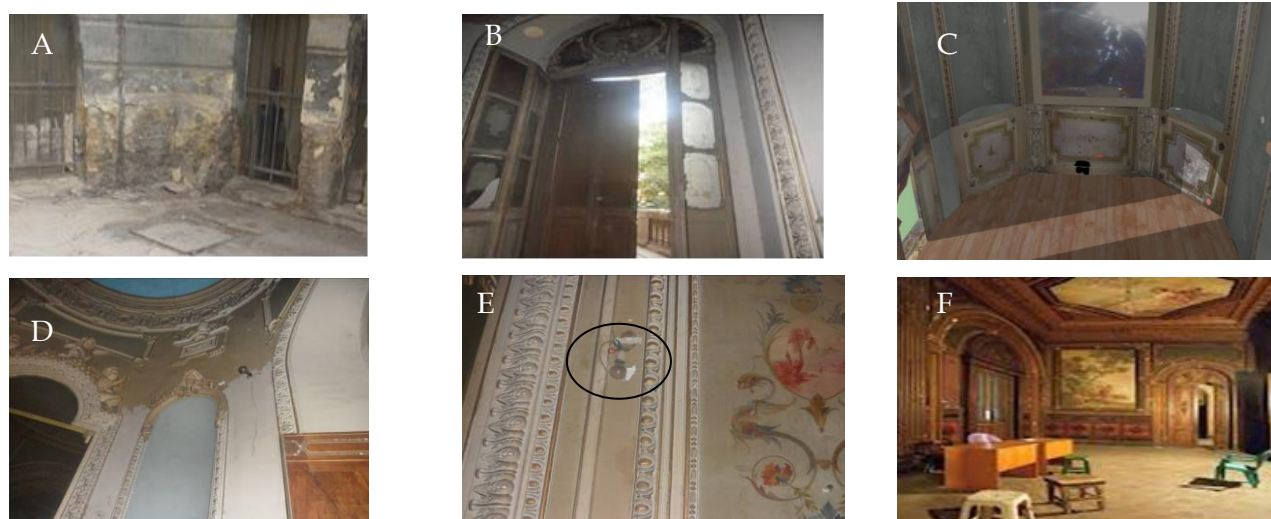
-That palace was built on a dried lake called Karaga. So the walls of the basement suffer from the raising of groundwater (X-Ray diffraction assured that the major salt is Halite which increase especially in walls close to the ground) (Fig. 1a ).

-The style of the palace is the Italian style which used huge windows which exposed the mural paintings to the daily sun light (Fig.1 b,c) .

-As the palace used as office for curators: Modern paint on walls, random electricity, and using a lot of chairs and desks (Fig.1 d,e,f).

The most vital deterioration factors facing the mural paintings are: a) salts in the rising ground water, b) the daily sun light which dried the paintings so the salts polymerized so it's became bigger producing an interior compression causing the detachments of paint layers as shown in (Fig.1c).

*Figure 1 The deterioration factors facing El Sakakeny palace , (A) The ground water in the external walls , (B)the huge window in El Sakakeny palace , (C) The sun light affect the mural painting in front of the huge window causing detachment of the paint layers , (D) The modern paints ,(E) The random electricity as the lamp is touching the wall causing detachment of the paint layer , (F) The chairs and desk for the too many curators inside the palace .*

assured the occurrence of deterioration (Arnold et al.,1987), which caused the detachment of painting layer (Ashurst,1998) (Fig. 2 a,b) so the problem of raising of groundwater in the wall a very vital problems faced all the mural paintings in the palace so that problem must be solved by prevent raising groundwater in the walls using the polymeric taps Albiotimin (Kumar ,2010).

2. The problem of detachment of paint layer can be solved by stopping the exposing to the daily sun light (Mora et al., 1984) by covering the mural paintings with special glass sheets (ultraviolet reflector) (Middleton, 2008).

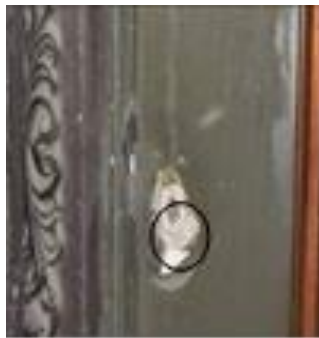
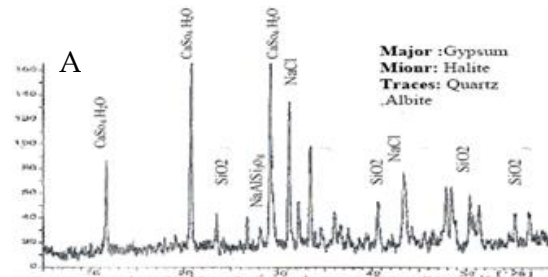
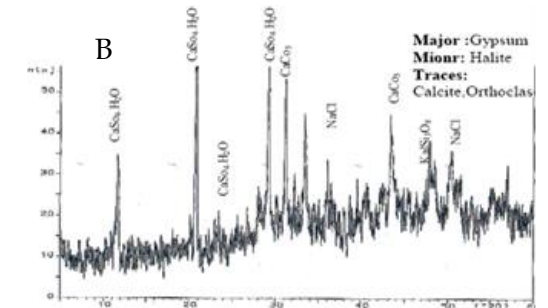
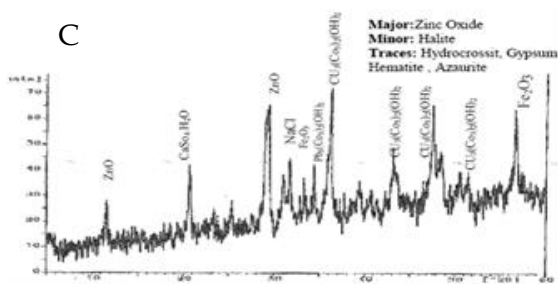
1. Halite is the major salts in all samples as it appeared in the original mortar 21% percent because of the groundwater which raised in all the walls of the palace, 19% percent of the ground layer, and 36% percent in the outside wall close to the ground

Figure 2 : X-Ray patterns of the samples from El Sakakeny palace (A) The original mortar Consisted of gypsum ,Quartz, Albite and 21% Halite , (B) The sample were taken from the outside wall close to the ground the percentage of Halite 36% which assured the raising of groundwater in the walls ,(c)The sample was taken from the color in back ground of the damage mural painting to define if the percentage of Halite which caused the detachment or not but the result assured that the Halite percentage is 19% so it is causing the detachment.

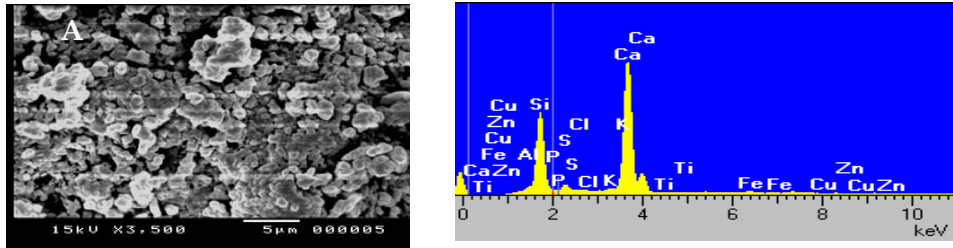
resumed Figures 3 to 5. The observations made by SEM of deteriorated walls show the appearance of halite crystals with a very high percentage (the salt was identified by XRD) on both surface and depth .

Figure 3. A Sample taken from the original mortar contained 19% halite

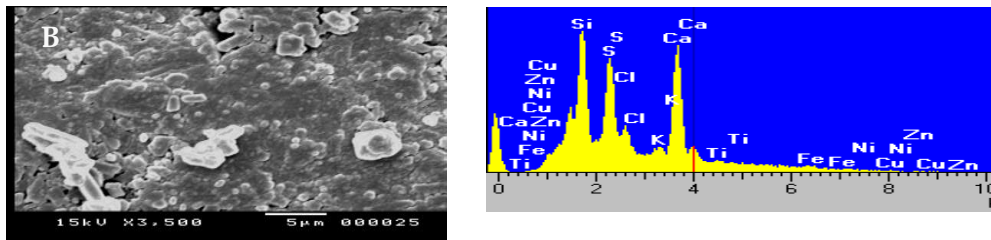
Figure 4. B Sample taken of ground layer and show the big quartz crystals which approved the homogeneity of the mortar

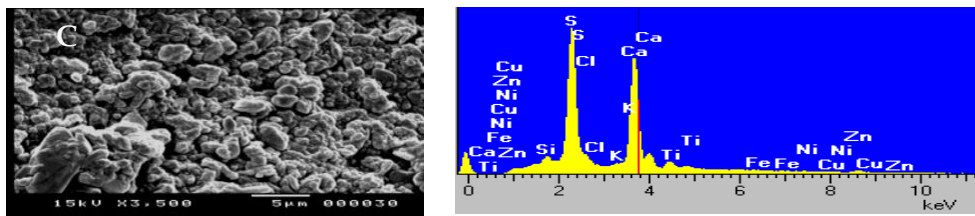
Figure 5 C Sample of reddish brown color which is a mixture of azurite and Hematite with little percentage of magnetite the big crystals of salts appear
